DEPARTMENT OF TRANSPORTATION

Contract #: 04-0120F4Cty: SF/ALA Rte: 80 PM: 13.2/13.9File #: 69.28**WELDING INSPECTION REPORT****Resident Engineer:**Pursell, Gary**Address:** 333 Burma Road**City:** Oakland, CA 94607**Report No:** WIR-010759**Date Inspected:** 14-Dec-2009**Project Name:** SAS Superstructure**OSM Arrival Time:** 1900**Prime Contractor:** American Bridge/Fluor Enterprises, a JV**OSM Departure Time:** 700**Contractor:** Zhenhua Port Machinery Company, Ltd (ZPMC), Changxing Island **Location:** Shanghai, China**CWI Name:** Wang Chung Ging, Li Yang**CWI Present:** Yes No**Inspected CWI report:** Yes No N/A**Rod Oven in Use:** Yes No N/A**Electrode to specification:** Yes No N/A**Weld Procedures Followed:** Yes No N/A**Qualified Welders:** Yes No N/A**Verified Joint Fit-up:** Yes No N/A**Approved Drawings:** Yes No N/A**Approved WPS:** Yes No N/A**Delayed / Cancelled:** Yes No N/A**Bridge No:** 34-0006**Component:** OBG/TOWER**Summary of Items Observed:**

OBG SEGMENT 6BE

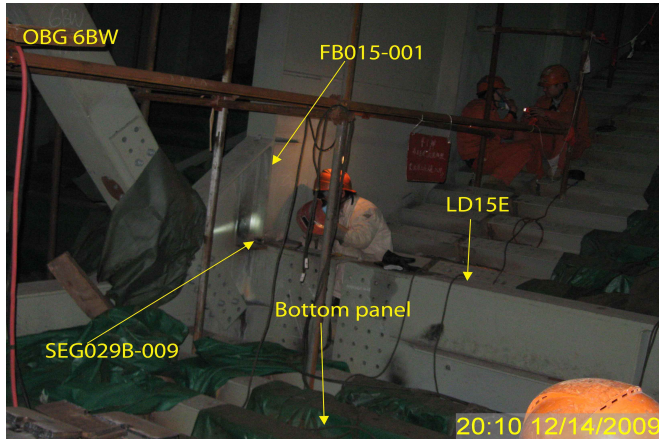
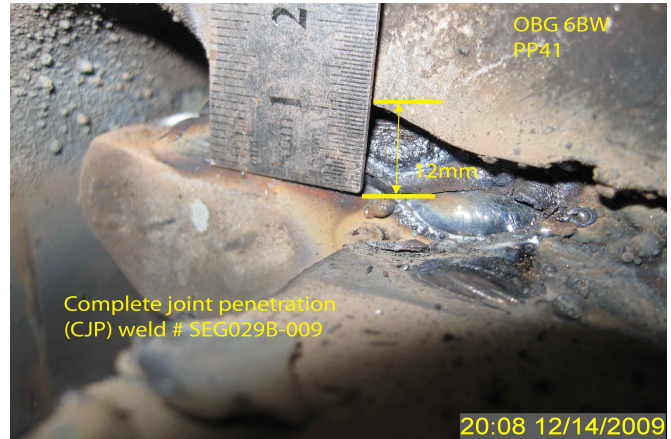
During a random in-process visual inspection of OBG segment 6BW, This Caltrans Quality Assurance (QA) Inspector observed an excessive root joint opening of a complete joint penetration (CJP) weld between the Floor Beam (FB) Flange and Top Flange of the Longitudinal Diaphragm (LD) located at PP41 and W4. This Quality Assurance (QA) Inspector informed to ZPMC CWI (Li Yang) and incident report is going to be issued to document excessive root gap.

- 1) The affected weld is identified as: SEG029B-009
- 2) This weld is a Complete Joint Penetration (CJP)
- 3) The Floor Beam Flange is identified as: FB015-001
- 4) The Top Flange of the Longitudinal Diaphragm is identified as: LD15E

For further information, please see the attached pictures below. Incident report was generated.
